Automated Sidewalk Quality and Safety Assessment System

Final Report
September 2015

**GEORGIA DOT RESEARCH PROJECT 12-16
FINAL REPORT**

GDOT Research Project 12-16
STRIDE Project Number: #2012-067S

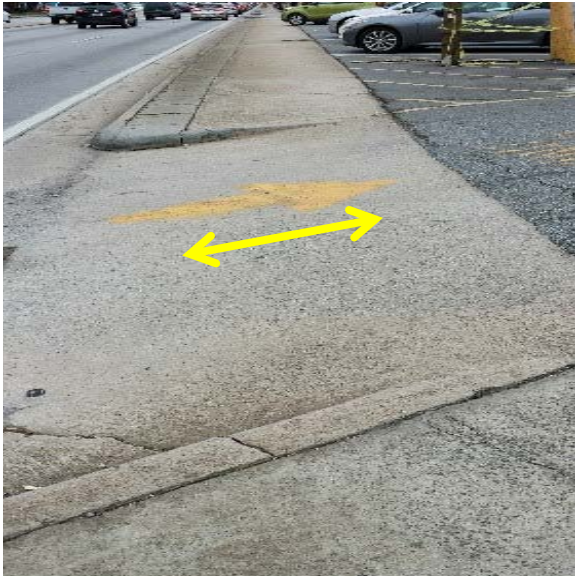
Photo of Typical Sidewalk Problem	Non-conformance with Federal Criteria (ADAAG/PROWAG)
 	<p>Sidewalk width is less than 36 inches</p>
 	<p>Sidewalk running-slope is greater than 5%</p>

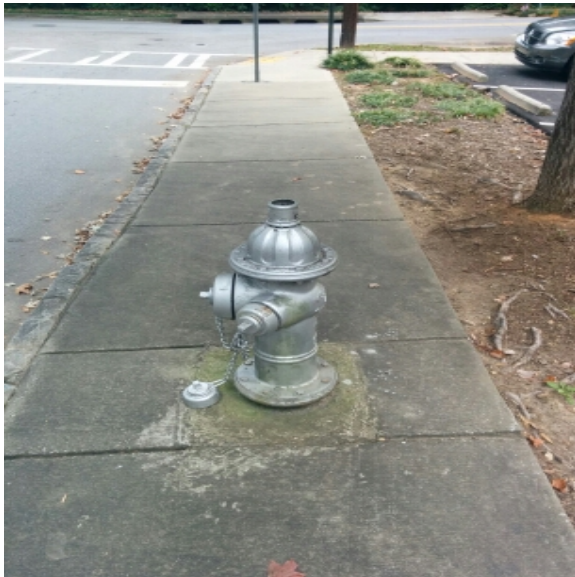
Sidewalk cross-slope
is greater than 2%

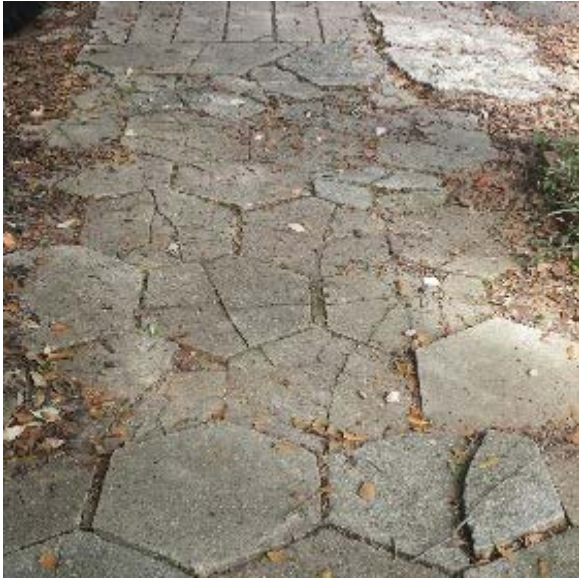
Sidewalk obstruction
is present

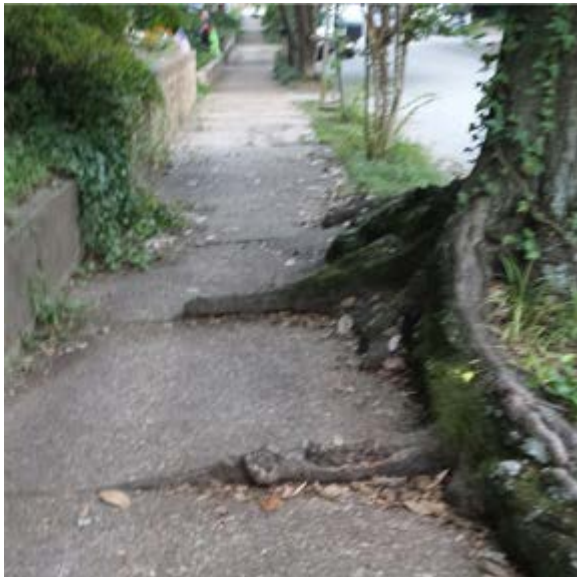
Pavement material is not
“firm, stable, and slip-resistant”

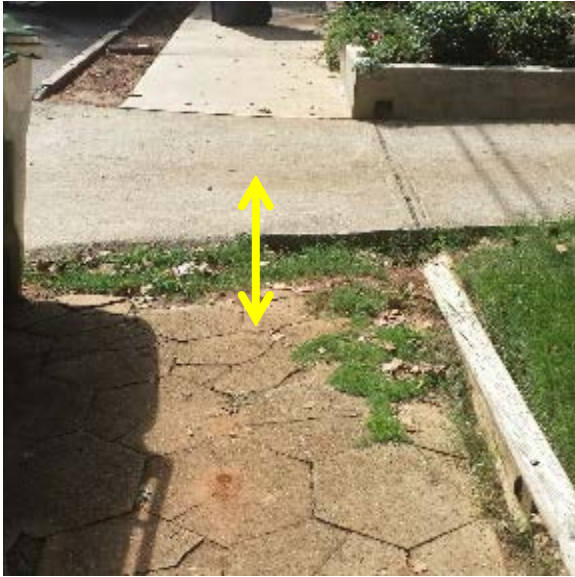
Vertical displacement
is greater than 1/2 inch and
a proper ramp (8.33%) is absent
Example 2

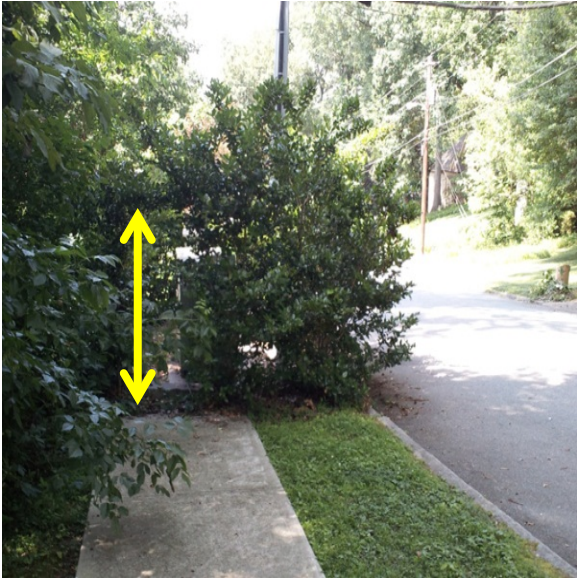
Vertical displacement
is between 1/4 inch and 1/2 inch
and surface is not beveled 1:2
(requires milling or patching)

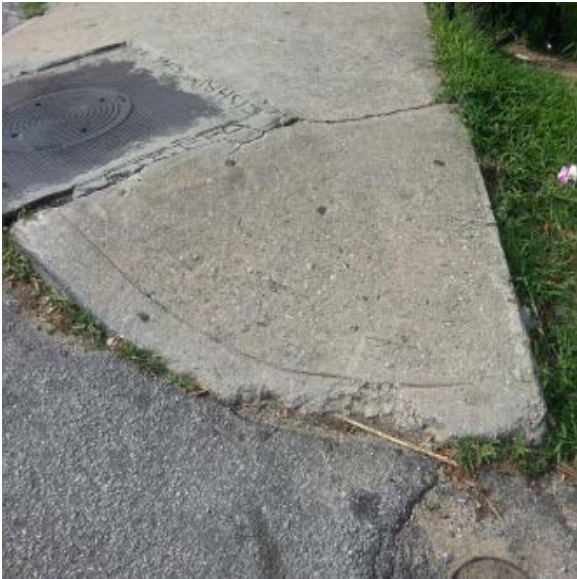
<p>Ramp width is less than 36 inches</p>

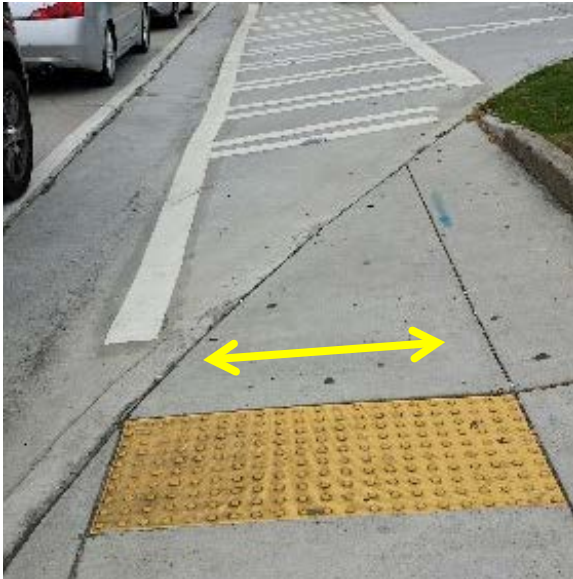
Ramp cross-slope
is greater than 2%

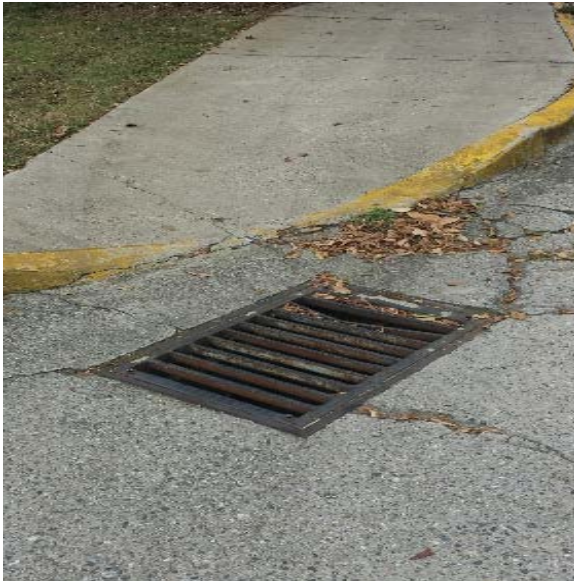
Passing area behind the ramp
is less than 36 inches deep
(36 inches ramp width by 36 inches deep)

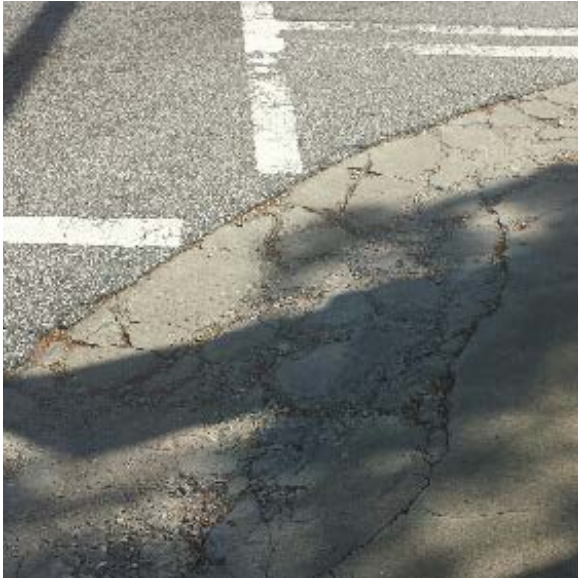
Ramp obstruction
is present

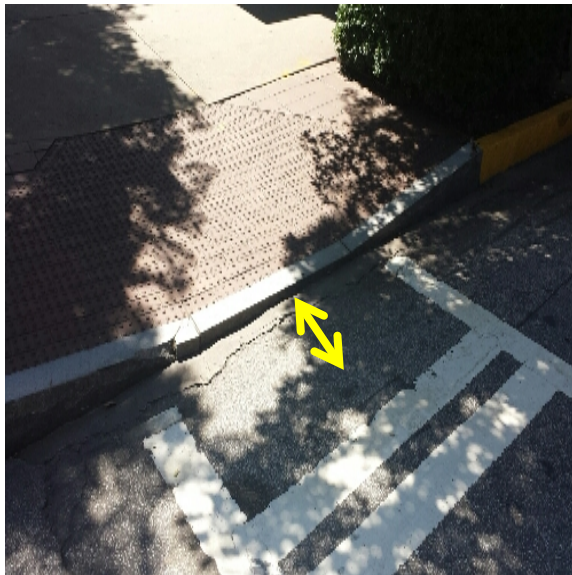
Gutter slope (from road to ramp)
is greater than 5%

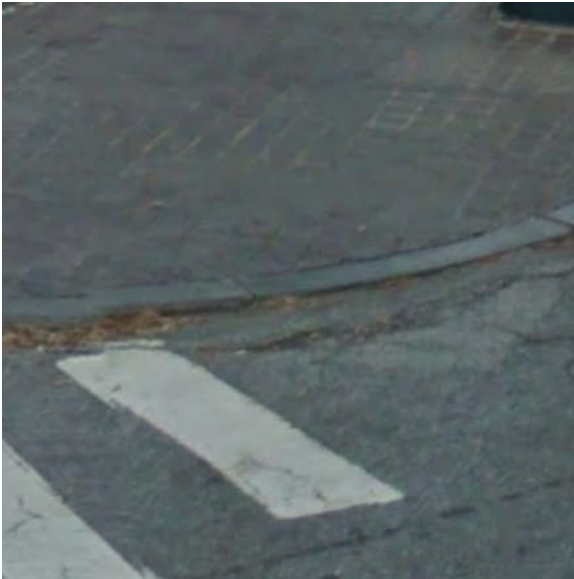
Road to gutter transition
is not flush

Vertical displacement is greater than 1/2
inch without a sloped ramp, or is between
1/4 inch and 1/2 inch without a 1:2 bevel

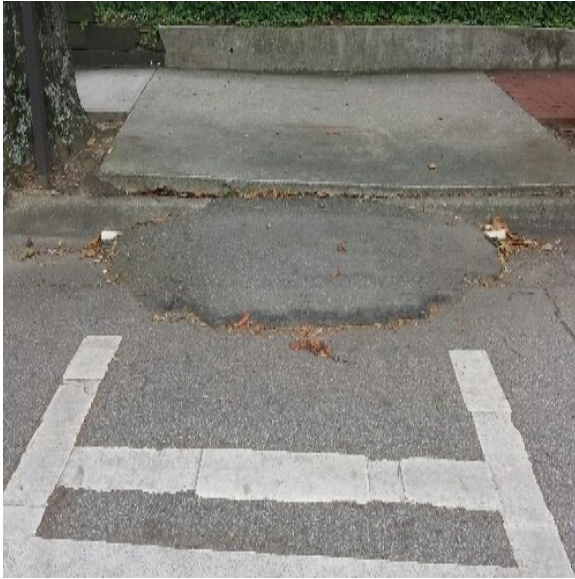
Gutter to ramp transition
is not flush

Vertical displacement is greater than 1/2
inch without a sloped ramp, or is between
1/4 inch and 1/2 inch without a 1:2 bevel

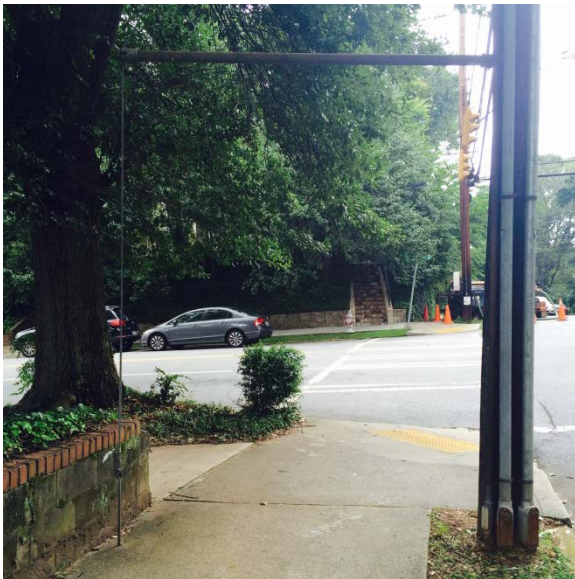
Ramp to sidewalk transition
is not flush

Vertical displacement is greater than 1/2
inch without a sloped ramp, or is between
1/4 inch and 1/2 inch without a 1:2 bevel

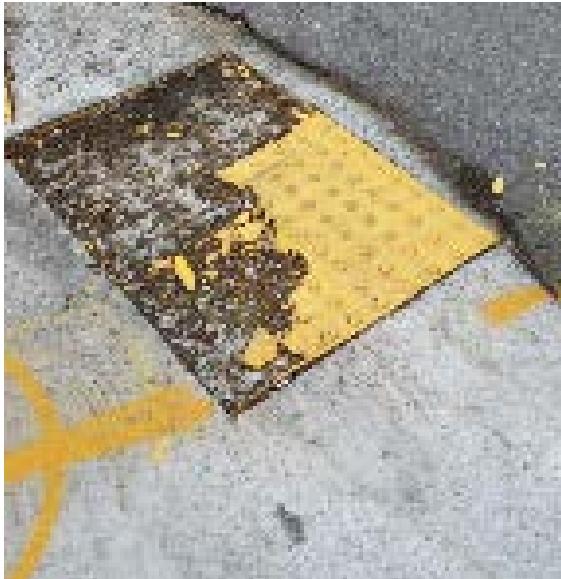
Detectable warning surface
(texture pad) is missing

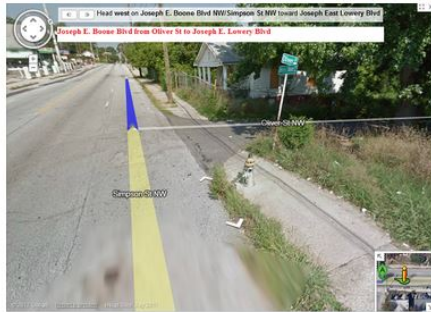
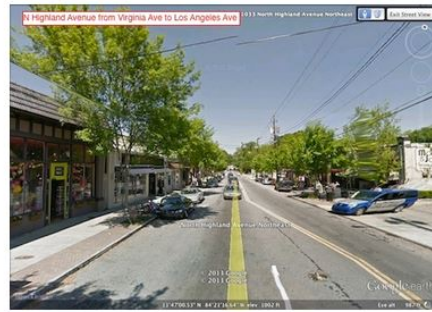
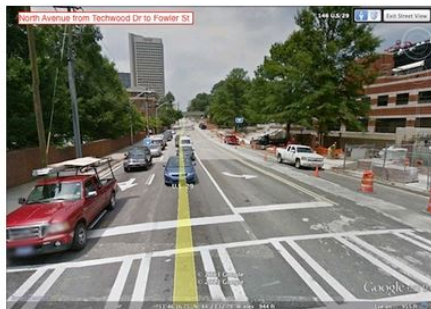
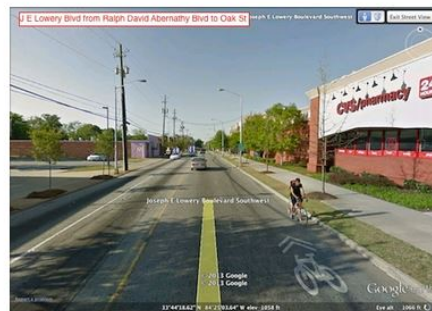
Figure 4. Screenshot from Start of Sidewalk Assessment Survey

This page shows the four sidewalk segments in this set. The first step is to assess each of these sidewalks individually. Please click on each segments name or image and complete its individual evaluation. Only after completing individual assessments for these four sidewalk segments, click Next on this page and complete the relative evaluation.

The survey begins with a survey overview page, which leads survey takers to a page with four randomly selected sidewalk segments from the database of 40 possible segments. Respondents choose one segment to start and are brought back to the 2X2 grid of the given segments for their survey iteration after rating each individual sidewalk segment. Figure 4 shows this first survey page with the four random segments to rate. The photos show a street view of the sidewalk location. When the user clicks on the photo, a segment evaluation page "pops up" for completion by the user.

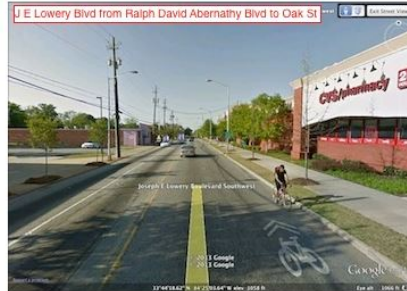
Segment Length = 0.2 miles
Initial grade = 3.1%
Initial cross-slope = 0.2%
Initial width = 4.35ft
Transit Nearby: MARTA rail station,
two MARTA bus routes
Schools Nearby: Atlanta University
Center, Brown Middle School
Development Nearby: commercial,
residential, transit station

J.E. Lowery Boulevard from Ralph David Abernathy Boulevard
to Oak Street (courtesy of Google Maps)

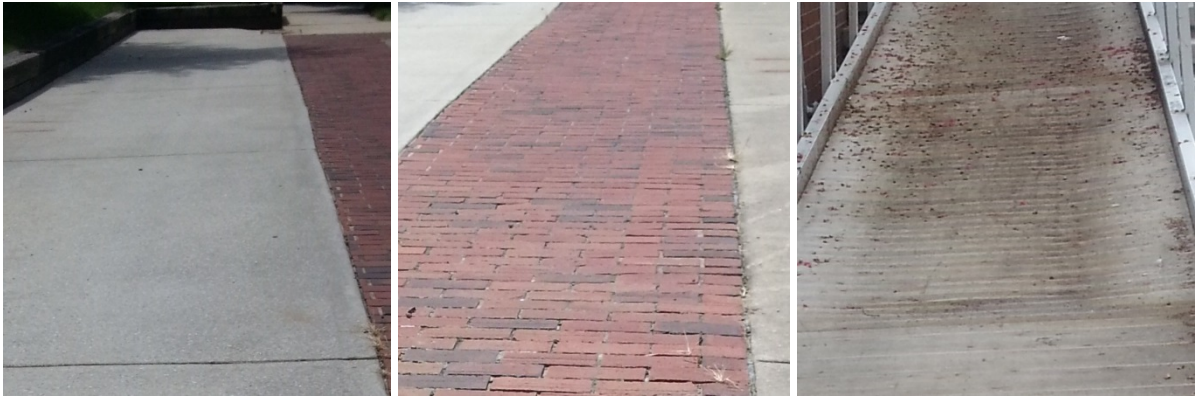
Figure 15. View of the Three Surfaces Tested

Three different surfaces, arranged from left (Surface 1) to right (Surface 3) in Figure 15, were used to collect a total of 65 runs. Surface 1 was the smoothest surface, composed of standard concrete with joints approximately every 36". Surface 2 was a rougher surface composed of red brick pavers. Surface 3 was the roughest surface comprised of an old metal ramp (washboard surface). Surfaces 1 and 2 were 19.2 meters in length (63.0 feet), whereas surface 3 was 9.3 meters (30.5 feet). The mean run speeds were 1.6 m/s (3.6 mph), 1.7 m/s (3.7 mph) and 1.7 m/s (3.8 mph), for surfaces 1, 2, and 3 respectively. The standard deviation of runs for all three surfaces was less than 0.1 m/s (0.2 mph).

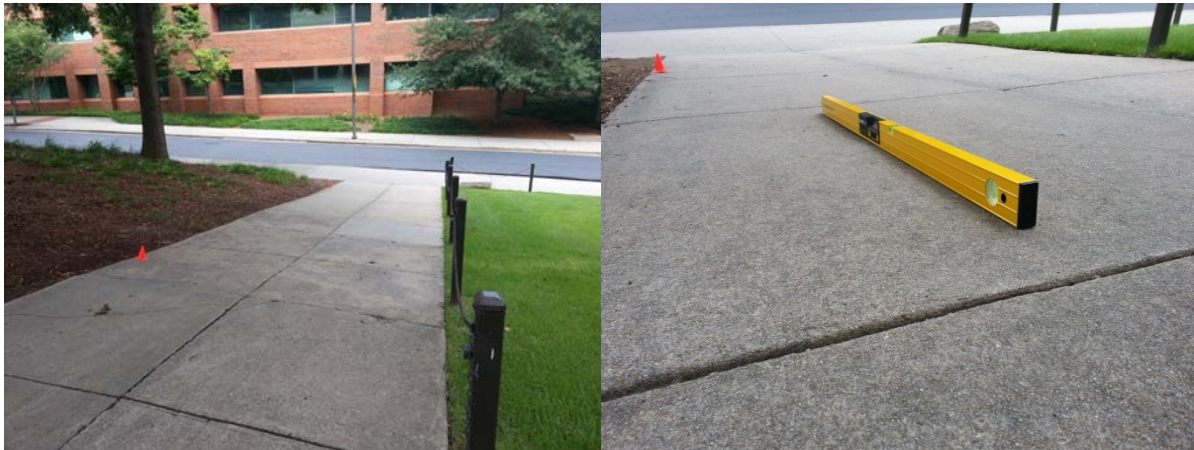
Figure 19. Initial Grade Field Data Test Location and SmartTool™ Digital Level

The purpose of the initial on-campus field experiment was to assess the basic capability of the Toshiba Thrive™ tablet wheelchair-mounted system to capture linear sidewalk grade. A simple experiment was devised to test a small grade section at the Georgia Tech campus. If the initial tests on the campus control section were successful, the team would then conduct more detailed tests on the Virginia-Highland control route with greater variability in grade and sidewalk condition (because vibration levels could affect grade accuracy). Reference grade (degrees) data were measured using a SmartTool™ digital level for each successive concrete slab on the sidewalk (Figure 19). For each slab, grade measurement (in degrees) were collected four times using the SmartTool™ digital level (two measurements used the equipment facing uphill, and two were facing downhill). Table 1 contains the SmartTool™ measurements. For the final estimate, the four results are averaged. The team then deployed Sidewalk Sentry™ on the Toshiba Thrive™ and deployed the GCDC X16-1C accelerometers on the same wheelchair to collect grade data for the same stretch of sidewalk.

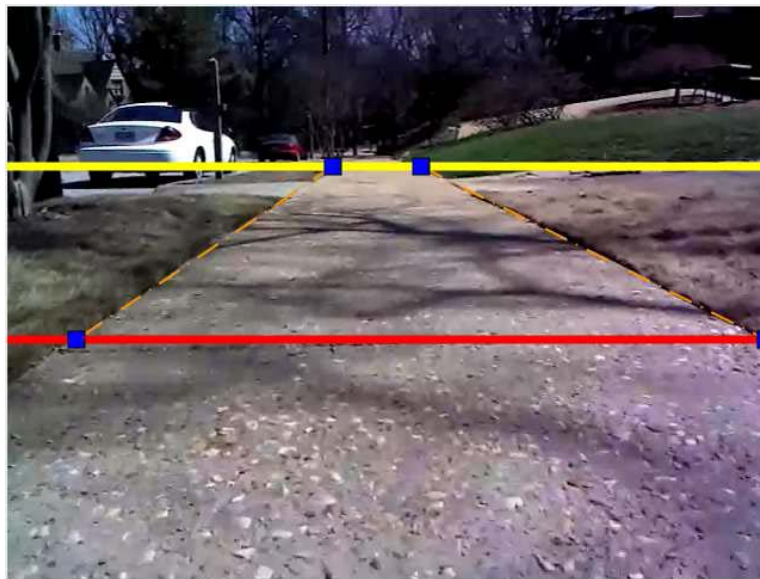
Figure 26. Width Estimation Interface

The research team developed an interactive web page that would allow registered users to review video and manually detect sidewalk edges. The system then automatically estimated sidewalk width using the calibrated field of view. The GPS data and elapsed time from the start of the video are employed to show the reviewer a frame from the video approximately every 50 linear feet. The interactive page allows the user to adjust sidewalk edge detection bars until they align with the edge of the sidewalk (see Figure 26). For each frame, researchers indicate two points on each side of the sidewalk by dragging the blue squares to match up with the picture. The orange dotted lines guide the researcher to line the boxes up accurately by aiming for the orange lines to align with the sides of the sidewalk. Once this information is entered, researchers have an automated system to convert the distance between pixels to dimensions in real life thus giving an estimate for the width of the actual sidewalk.

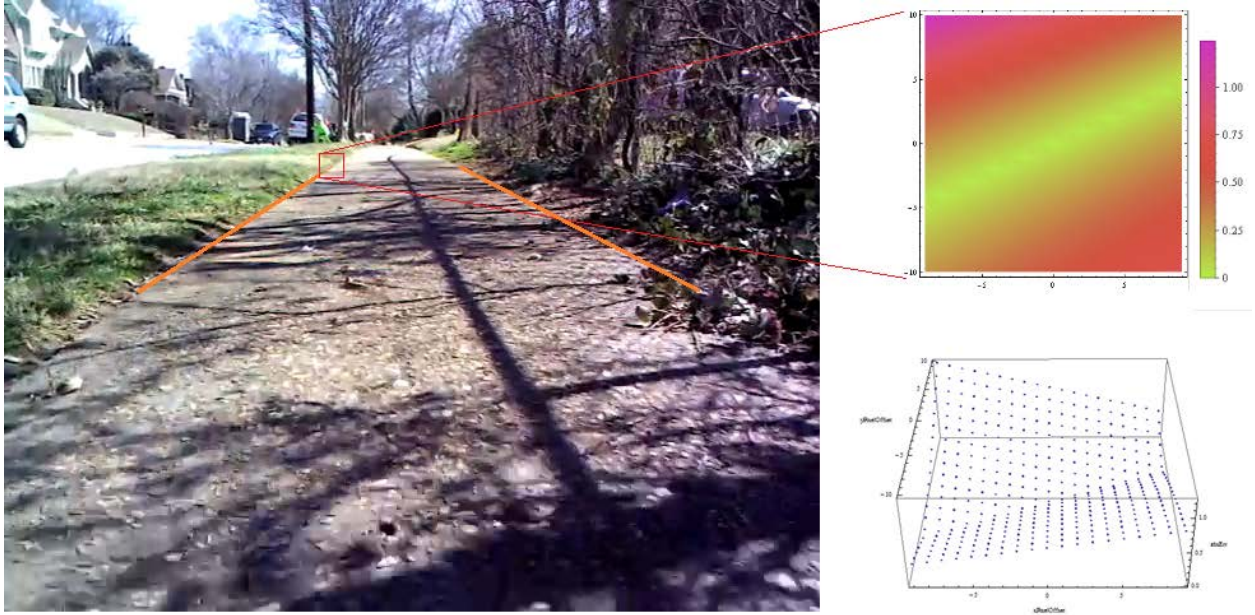
Figure 27. Width Estimation Sensitivity Example

Because the estimation of sidewalk width is dependent on user-identified sidewalk edges, it is important to assess potential biases across users. It is unlikely that users will be able to replicate the exact points chosen for drawing edge-detection lines. Edge detection requires placement of four coordinates on the screen. Given the coordinate transformation assumptions, the estimated width can only equal the ground truth width when all four edge-detection pixels are exactly where they are supposed to be. The sensitivity analysis considers the movement of one of the pixels furthest away from the camera. Movement of one of the edge vertices from ground truth will result in error in the width estimation. The distance this point is away from the camera and its spatial relationship to other points will influence the sensitivity of moving the point. Figure 27 below shows the sensitivity of moving the upper left edge-detection point up to 10 pixels in any direction from the ground truth point. As expected, there are many other points along the ground-truth edge that can be selected resulting in an accurate width estimate. The further away from the edge, the larger the width estimation error that can be expected.

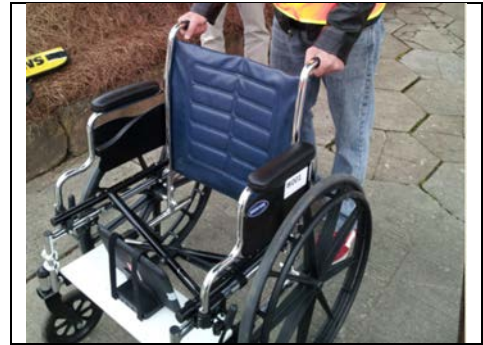
Field Data Collection Unit Setup

- 1) Turn on tablet, unlock tablet
- 2) Open “Sidewalk Sentry” app
- 1) Login to Sidewalk Sentry, using your assigned username and the tablet number (marked on the side of each tablet)
- 2) Snap the white tablet mounting board onto the bottom wheelchair bars *below* the location where the seat would normally be (see photo), **not onto the top black folding bars**. The board will click into place with all four connectors.
- 3) Mount the tablet to the black tablet mount on the white mounting board such that the screen is horizontal and facing towards the person pushing the wheelchair (allowing the camera on the back side to point down at the sidewalk).
- 4) Once the Tablet is secured in the mount, tighten the 2 Velcro straps over the top of the tablet to reduce excess vibration.

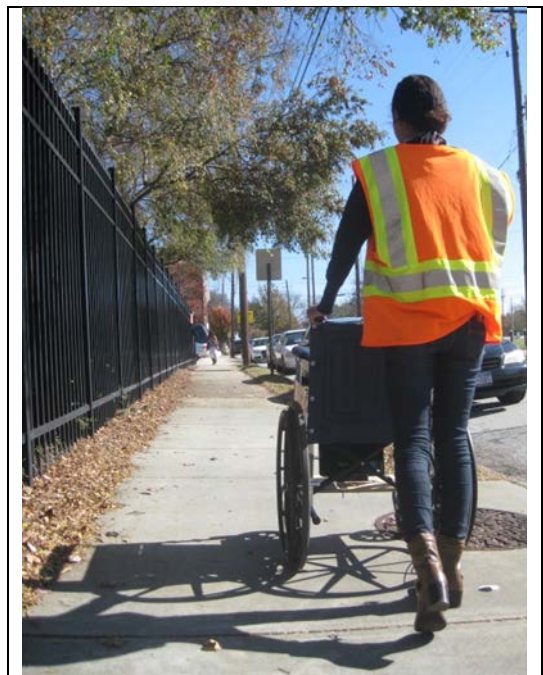
Field Data Collection in Progress

- 1) Go to the denoted start point on the route map.
- 2) Setup the wheelchair and tablet at the start point facing in the proposed direction of travel.
- 3) Open the sidewalk Sentry™ application and press “get GPS fix.”
- 4) Wait for GPS fix to be established. You will hear a beep and see the “Get GPS” button change to “REC” button.
- 5) Press “Rec.”
- 6) Wait 10 seconds.
- 7) Push wheelchair at a normal walking speed (between 2 and 3 mph) along route. Let wheelchair bounce along the route (do not dampen vibrations by holding the wheelchair down)
- 8) Walk along route in direction of arrows...

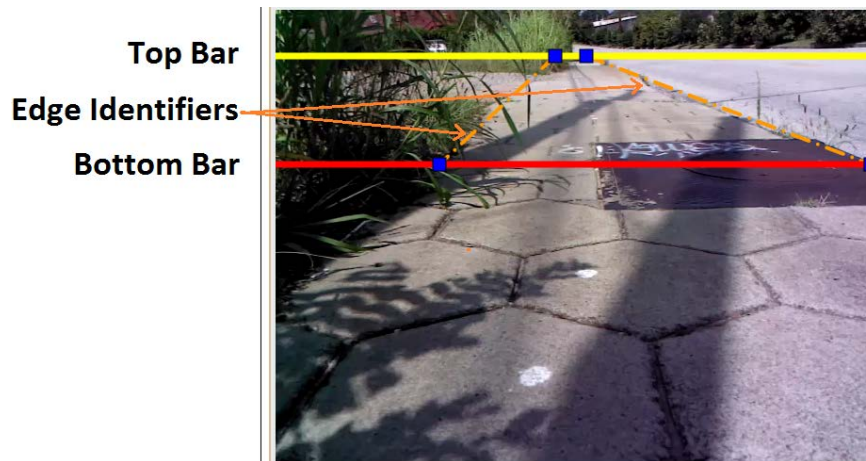
Figure 54. Placement of the Sidewalk Edge Identifiers in the Field of View

1. Slide the lower bar (click and drag) until it is just above both edges of the sidewalk.
2. Slide the upper bar until it roughly coincides with the horizon line.
3. Slide the endpoints of the edge identifiers along the upper and lower bars until they coincide with each sidewalk edge.
4. Select the "Save Coord" button at the right of the image

In the real world, sidewalk edges are parallel to each other. That is, the distance between the two orange lines, in the real world, remains the same from end to end. In the camera view, the edge lines angle off into the horizons and meet at what is known as the “vanishing point” in the camera view perspective. Because a mathematical equation is used to calibrate the camera field of view using the location of the vanishing point, it is important that the edge lines follow the sidewalk edges as accurately as possible.

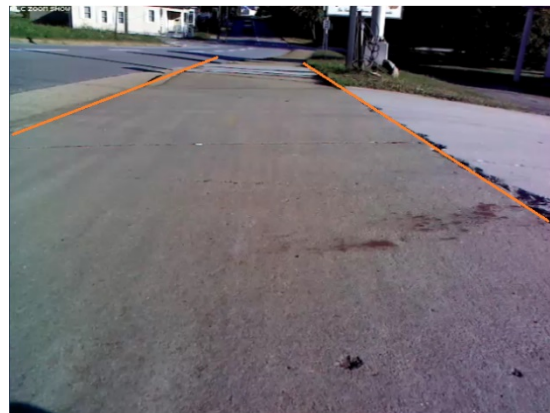
Figure 58. Correct Edge Identification at Crosswalks

Crosswalks are not sidewalks. But as long as the user can see enough of the sidewalk edges (see Figure 58), the lines can be placed and width can be estimated. Otherwise, the user employs the skip frame option and selects “No Sidewalk” as the reason.

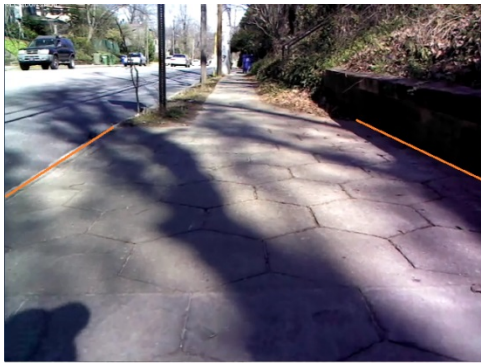
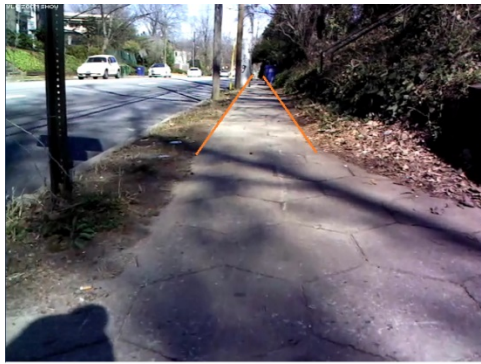
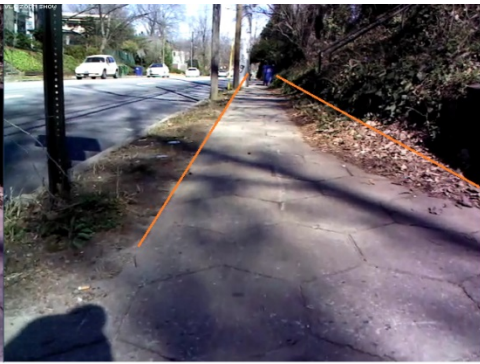
Figure 62. Additional Examples of Edge Identification

If the sidewalk changes widths, measure the width closest to the camera, unless the edges closest to the camera are too short to make an accurate estimate, or the actual sidewalk edges closest to the camera are not really parallel with each other. Only estimate sidewalk edges where a true edge exists. Figure 62 contains additional examples of correct and incorrect edge identification.

Correct Edge Identification	Incorrect Edge Identification	Incorrect Edge Identification
